Article

Hydromorphological Assessment as a Tool for River Basin Management: Problems with the German Field Survey Method at the Transition of Two Ecoregions

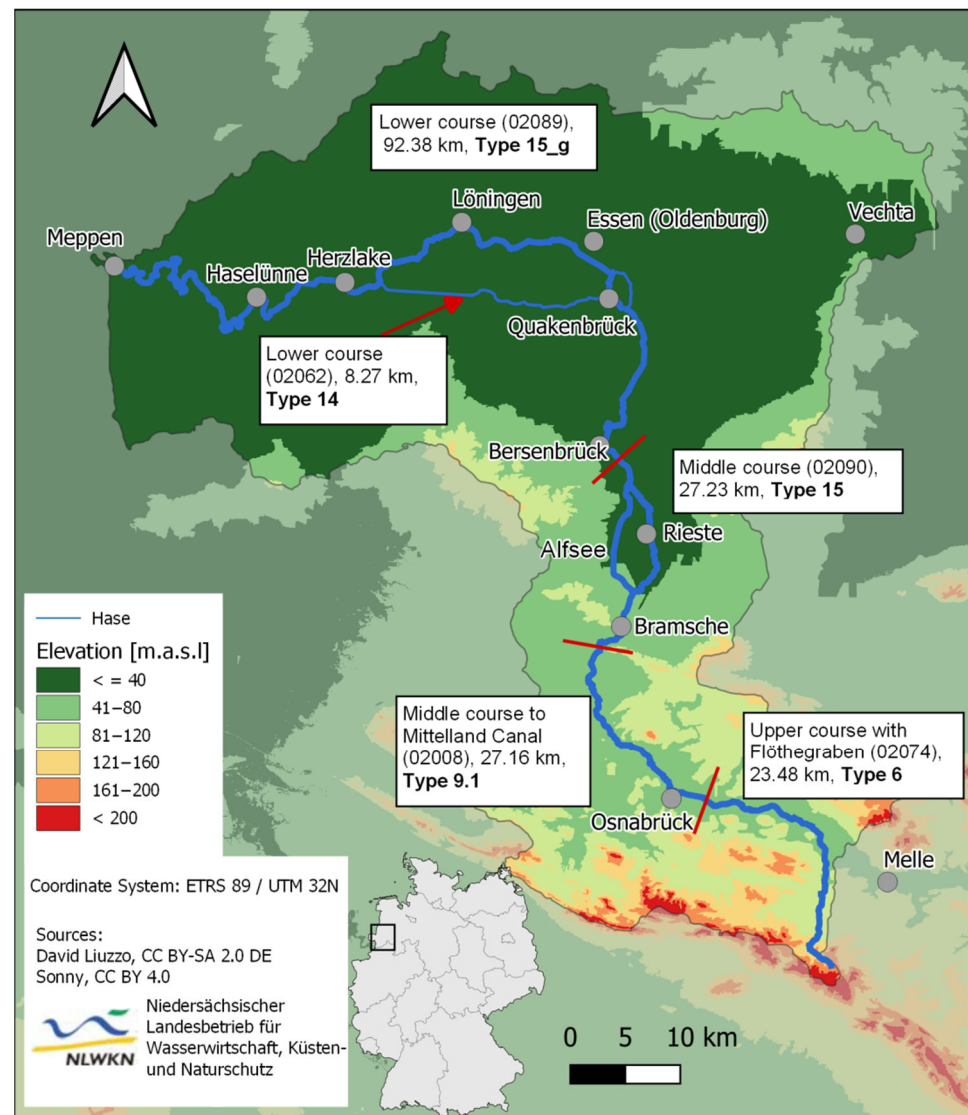
Figure 1. Relief map of the Hase catchment with the Hase watercourse, reference river type, number of NLWKN water body in parenthesis and length of the river section (data sources: [33–36]).

To achieve these objectives, the Hase River was chosen as a case example (Figure 1). The Hase River is located in Southwestern Lower Saxony and is the biggest tributary of the Ems River. The aboveground catchment area extends over 3086 km² of which 118 km² belong to North Rhine-Westphalia. The Hase River originates near Melle in the Teutoburg(er) Forest and, after 170 km, flows into the Ems River near Meppen. The mean annual precipitation in the catchment is 750 mm, whereas the precipitation in the catchment of the upper course exceeds the precipitation in the middle and lower courses. The long-

The Hase River is assigned to different LAWA river types (Figure 1). The upper course is assigned to type 6 (“fine material rich, carbonaceous highland streams”, Figure 2a). It consists of a mix of near-natural river sections and heavily modified river sections. The lower course belongs to type 15 and 15_g (“(large) sand and loam associated lowland rivers”, Figure 2b) and has been the object of intensive anthropogenic pressure due to intensive river maintenance and regulation of the water course and intensive land use. The results of these pressures are the heavily to completely modified river sections in 92% of the lower course [35].

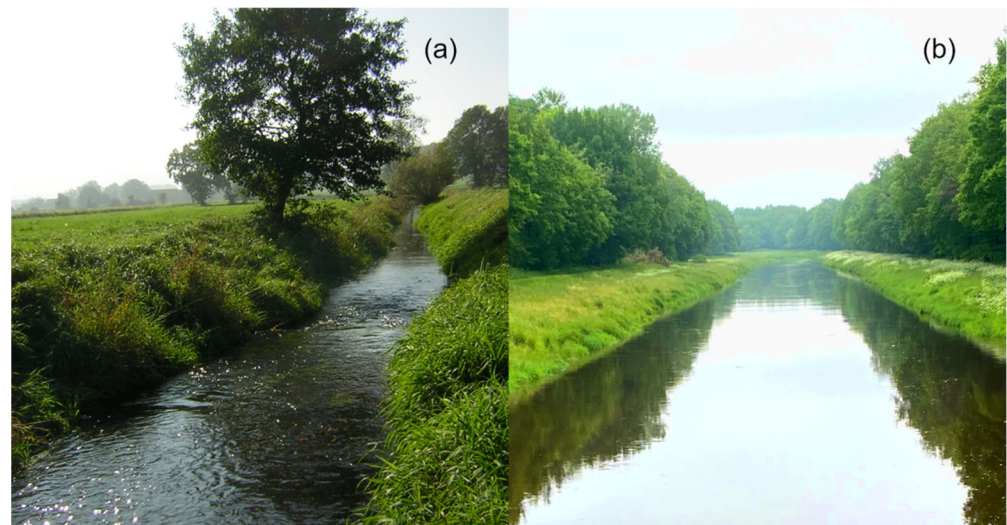
Figure 2. The Hase River in the (a) upper course (type 6, “fine material rich, carbonaceous highland streams”; source: Roman Rittner); (b) lower course (type 15, “sand and loam associated lowland rivers”; source: Joachim Härtling).

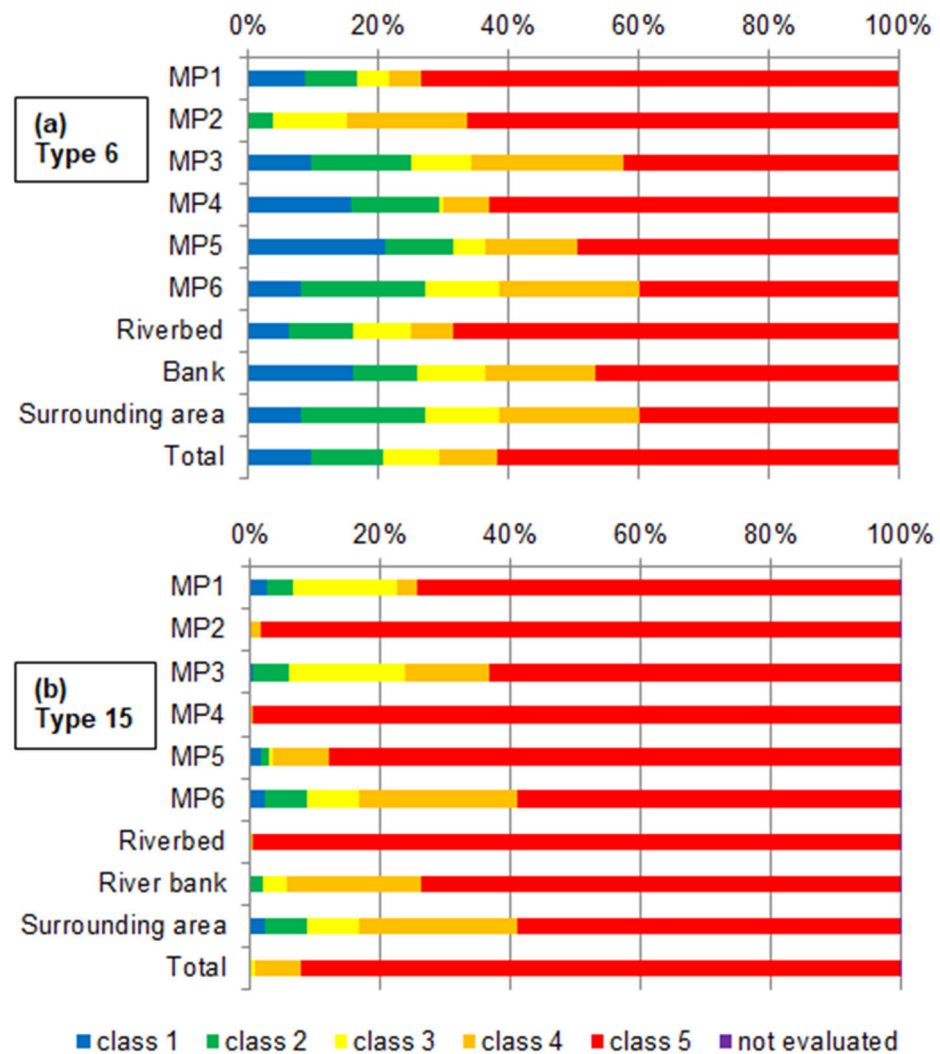
Figure 3. Structure classes 1 to 5 of the evaluation of the river type 6 (a) and river type 15 and 15_g (b) sections of the Hase River (uplands) of the main parameters MP1 to MP5 and riverbed, river bank, land and total evaluation.

The aim of the water framework directive is to achieve at least a good status of the rivers. In the type 6 river sections of the Hase, only one fifth (21%) of this part was in good or very good hydromorphological condition (Figure 3a). The results differed considerably between the main parameters. In the longitudinal section (MP2), only 4% of the river sections were in a good condition, zero percent were in a very good condition whereas in the riverbed structure (MP4) and the bank structure (MP5) up to one third of the river sections had already achieved good or very good hydromorphological status.

In the type 15 and type 15_g river sections of the Hase River, a good or very good hydromorphological status was not achieved in terms of the total evaluation (Figure 3b). The good status was also not achieved in the main parameters, longitudinal section (MP2) and riverbed structure (MP4). For the other main parameters, good or very good status ranged between 3% in the cross-section (MP5) and 9% in the watercourse environment (MP6).

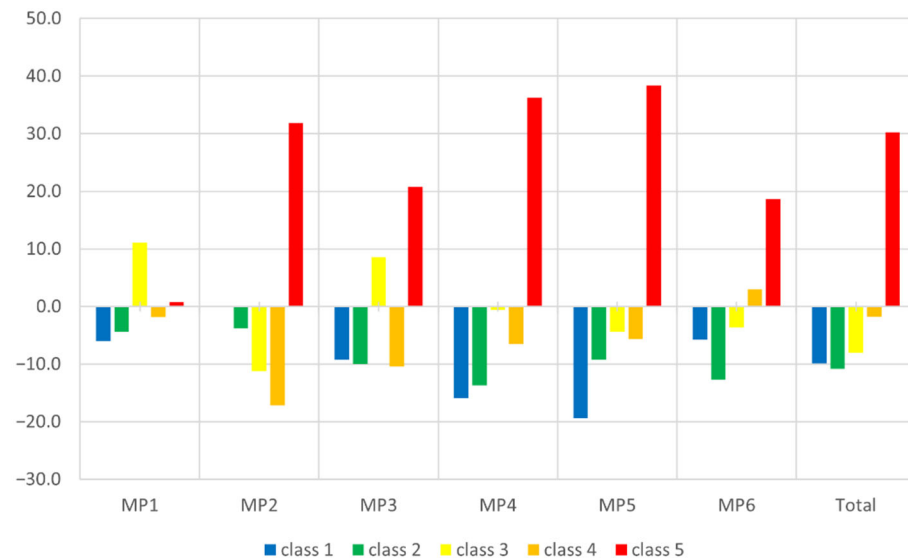
Figure 4. Difference [%] of the evaluation classes (1–5) of the Hase River between the Lower Saxonian Mountains (river type 6) and the Northwestern Lowlands (river type 15 and 15_g). MP1 = river development, MP2 = longitudinal section, MP3 = cross-section, MP4 = river bed structure, MP5 = bank structure, MP6 = watercourse environment, total = total evaluation. The middle course was not considered.

The comparison of the frequency of the evaluation classes between the upper and the lower course showed that in all main parameters and the total evaluation, class 5 occurred more frequently in the lower course than in the upper course. Classes 1 and 2 occurred more frequently in the upper course (Figure 4).

Class 5 was awarded up to 38% more often in the lower course (MP5; bank structure), and about 30% more often on average. In river development (MP1), the difference between the upper and the lower course in the evaluation class 5 was only minimal with less than 1%. Especially in the riverbed structure (MP4) and the bank structure (MP5), class 1 was assigned significantly more often in the upper course than in the lower course, with 16% and 20%, respectively. For the parameter longitudinal section (MP2), no sections were evaluated as class 1. For river development (MP1) and riverbed structure (MP4), class 3 was found in more river sections in the lower course than in the upper course. For all main parameters besides the watercourse environment (MP6), more sections in the upper course were evaluated as class 4 than in the lower course. In the total evaluation of the Hase River, classes 1 to 4 were found more frequently in the upper course than in the lower course. Class 5, on the other hand, was given more frequently in the lower course than in the upper course. On average, the classes 1, 2 and 3 were assigned 10, 11 and 8% more often in the upper course than in the lower course. The difference in class 4 between the two river sections was only small, with 25% more river sections in the upper part of the watercourse.

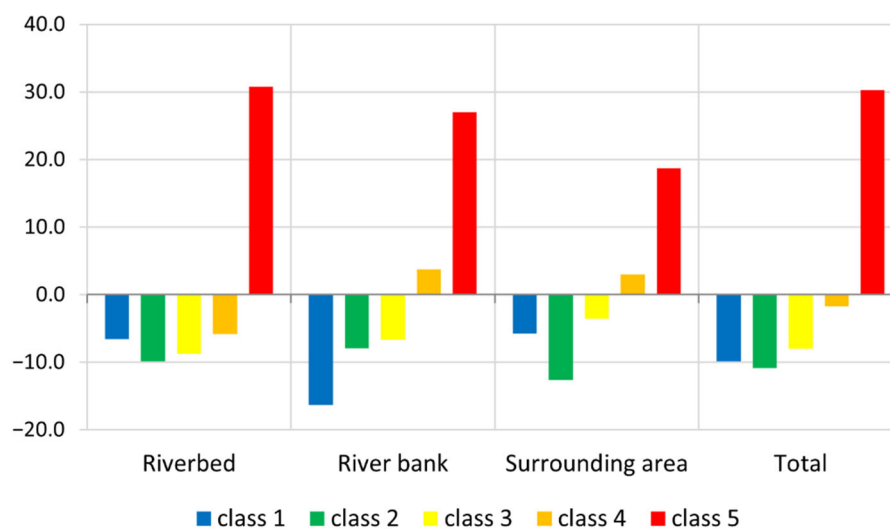
Figure 5. Difference (%) of the evaluation classes (1–5) of the Hase River between the Lower Saxonian Mountains (river type 6) and the Northwestern Lowlands (river type 15 and 15_g). The main parameters (MP1–MP6) are aggregated into the fields: river bed (MP1 = river development + MP2 = longitudinal section + MP4 = river bed structure), river bank (MP3 = cross-section + MP5 = bank structure), land (MP6 = watercourse environment/floodplain) and total evaluation.

If the evaluation of the main parameters is aggregated into riverbed, bank and surrounding area, the picture is only slightly different (Figure 5).

Class 5 was given more frequently in all aggregated parameters in the lower course than in the upper course. With 31%, the biggest difference between the lower and the upper course river sections was found in the riverbed. The difference in the bank was only slightly lower (27%). In the surrounding area (MP6), class 5 was still assigned 19% more frequently in the lower course. Classes 1, 2 and 3 occurred more often in the upper course compared to the lowlands. For class 4, a different distribution pattern emerged. In the riverbed and the total evaluation, more river sections were evaluated as class 4 in the upper course. In the bank and the surrounding area, class 4 occurred more frequently in the lower course.
